SOP 3: MULTIPOINT LOCK HARDWARE MALFUNCTION - WARRANTY CLAIM

SOP 2: CRACKING / DELAMINATION SLAB OR FRAME

EXAMPLES OF CRACKING / DELAMINATION ON VENEER

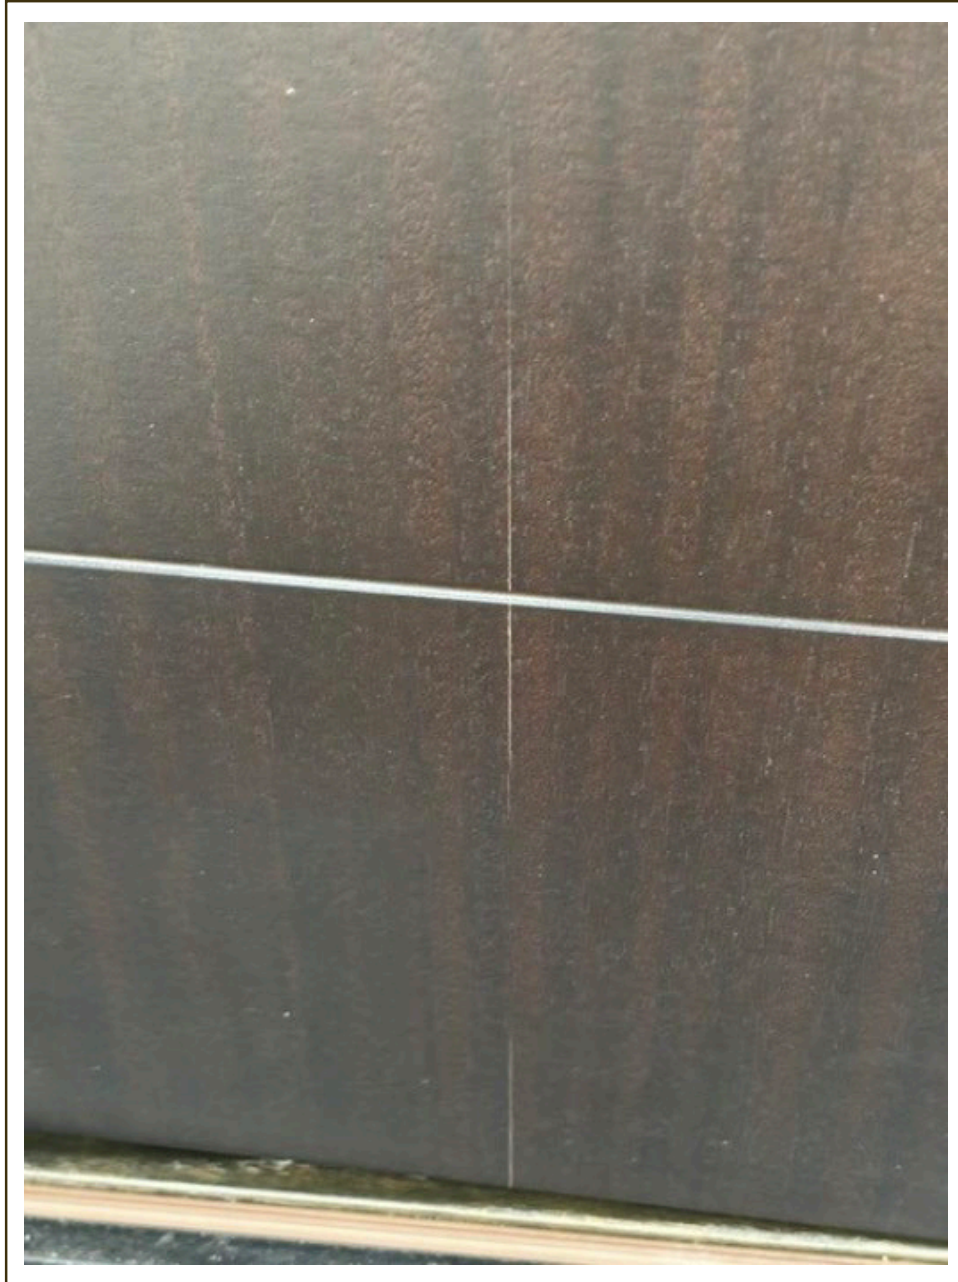
Example 2: Delamination of the veneer. Can appear as a scratch in photos but further examination in the field will show a split in the veneer which is raised off the panel.
