SOP 2: CRACKING / DELAMINATION SLAB OR FRAME

To standardize the claim process for surface cracking, veneer delamination, or structural blemishes on Glenview Eurotech wood doors.

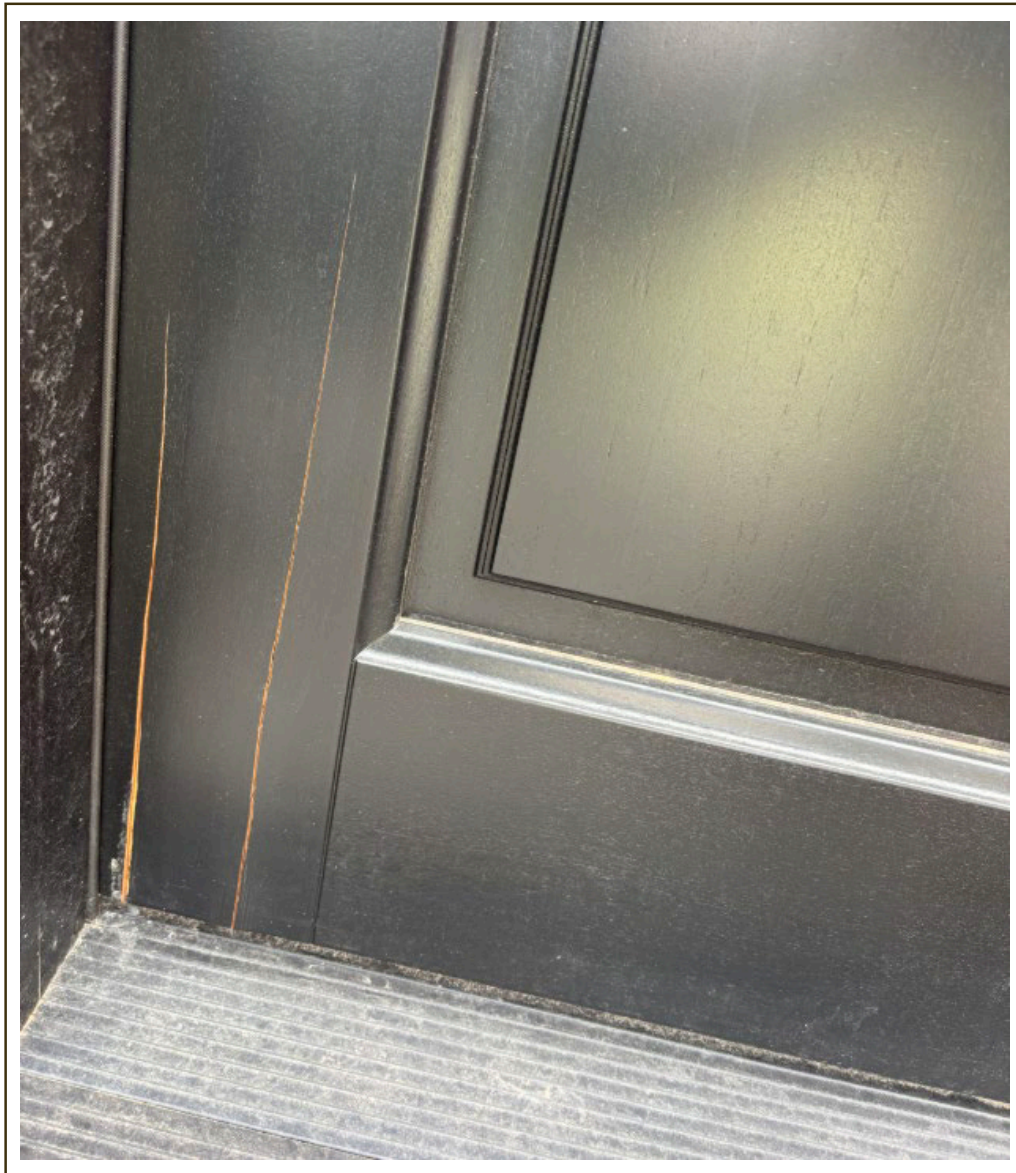
Example 1: Large Cracks on Stile.

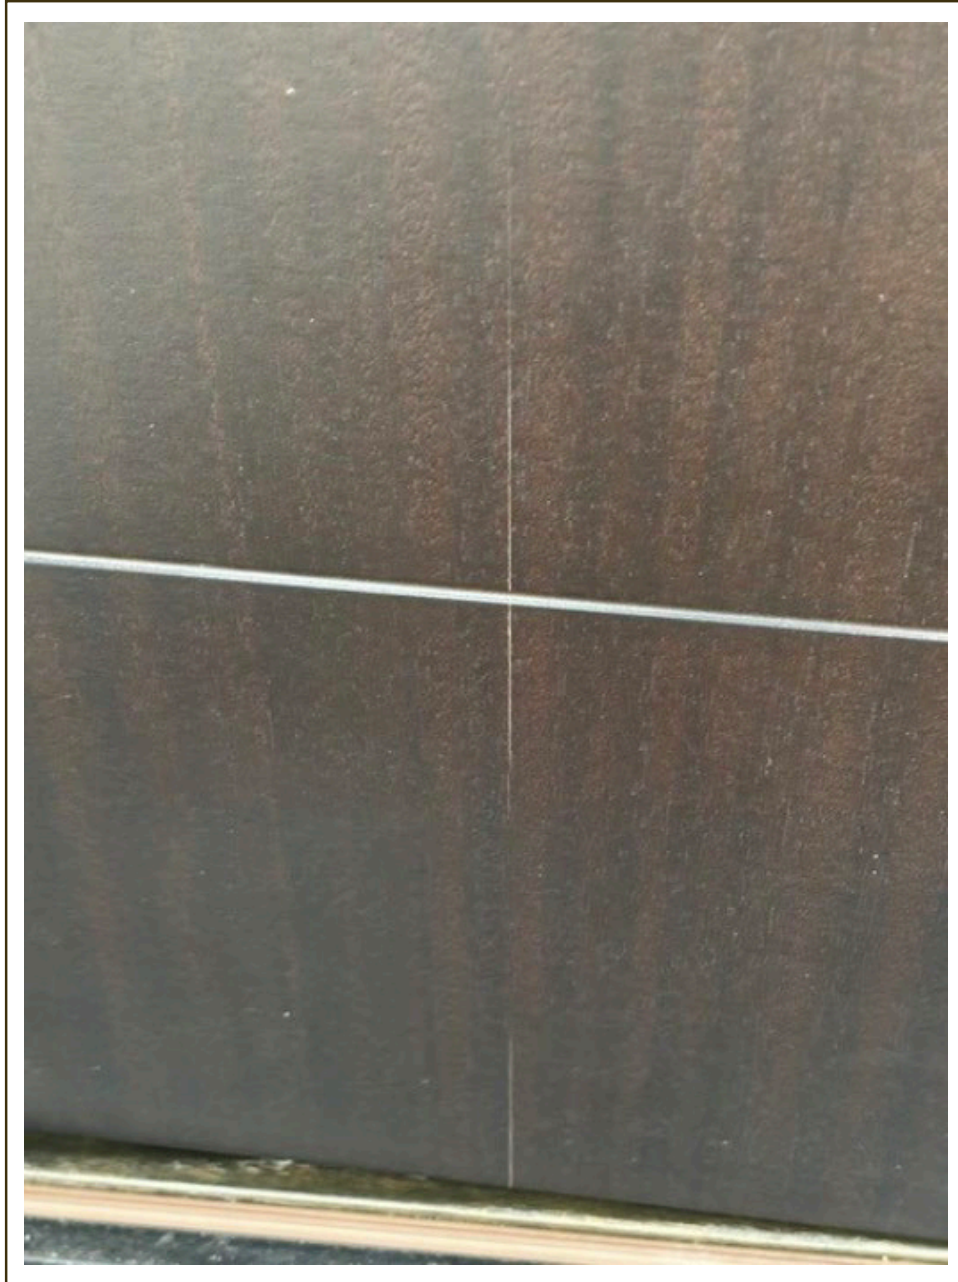
Example 2: Delamination of the veneer. Can appear as a scratch in photos but further examination in the field will show a split in the veneer which is raised off the panel.
